Inspection and/or replacement of the valve push-rod assy., rocker arm left and rocker arm right for ROTAX® Engine Type 912 i, 912 and 914 (Series)

ATA System: 72-30-00 Cylinder head

SERVICE BULLETIN

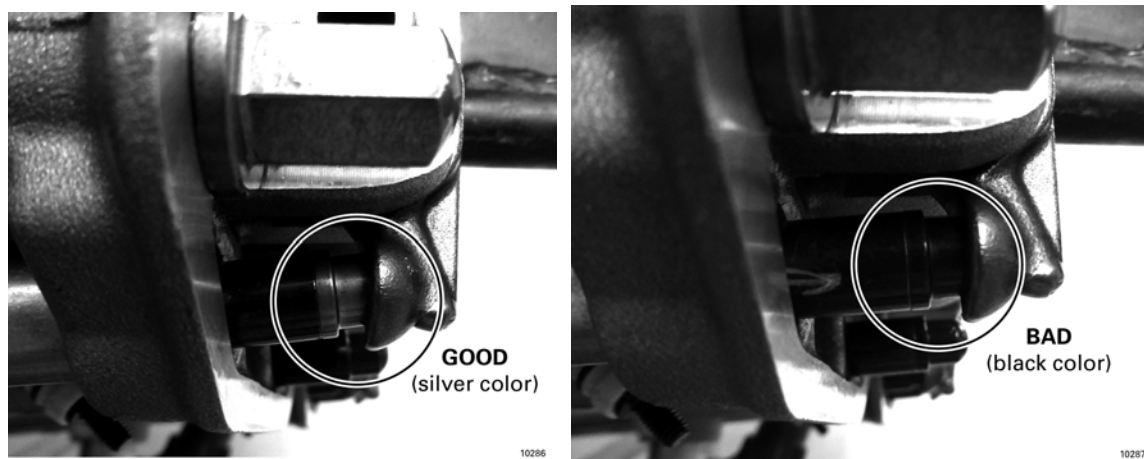
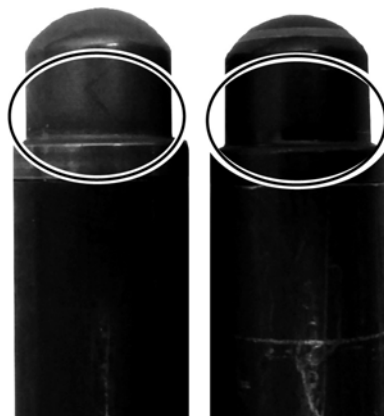
Fig. 1
Visual inspection

Due to deviations in the manufacturing process of the valve push-rod assy., partial wear on the rocker arm ball socket may occur. This wear might lead to a rocker arm cracking / fracture which in consequence may lead to a malfunction of the valve train. Possible effects are rough engine running or an unusual engine operating behaviour.

Perform visual inspection of all push-rod ball sockets on all cylinder.
 Check for color. See Fig. 1.

Color	Evaluation
Silver surface	Valve push-rod is OK. No further action required for this valve push-rod.
Black surface	Valve push-rod is NOT OK. See section. 3.1.3) Replacement of affected parts.

GOOD
(silver color)

3.1.3) Replacement of affected parts

On valve trains with valve push-rods found NOT OK the following steps need to be performed:
